FAULT ZONE LANDSLIDES: THE EFFECTS AND GEOMORPHOLOGICAL CHARACTERISTICS OF KOYULHISAR (SİVAS-TURKEY) LANDSLIDE, MARCH 2005.

One of the landslide areas of Turkey extends along the Northern Anatolian strike-slip fault zone. The dissected topography by the running water and fault lines and well and deep weathered parent materials has led to the mass movements especially landslides. The landslide called Kuzulu occurred on 17 March 2005 caused to destroy of the most part of the Kuzulu village and 15 people and 375 animals died. During the landslide a 15 million cubic meter materials has been slid from the original part and accumulated on the valley bottom.

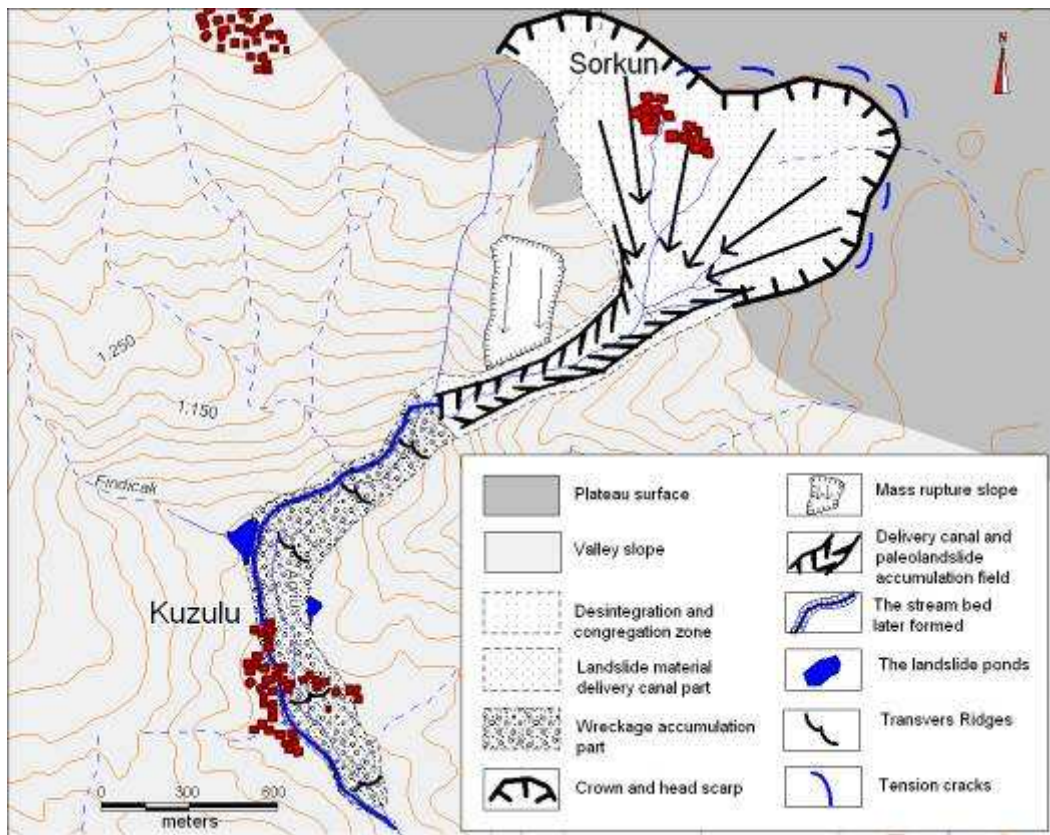
Figure 4: Geomorphological map of the landslide area

Landslide area is in shape of "Z" at altitude of 1550-1650 m in the upper part of the slope. This area can be termed the head of the landslide and the failure area. The middle part of the landslide area is the accumulation area of the slided materials and is in conic shape or resembling dejection cone. This accumulation area extends at the altitude of 850-1500 m and its inclination is more than 20 degree. The old cemented landslide materials form a spurs on the slided debris.

The accumulation zone of the landslide area is found lower part of landslide area and/or the lower part of the Kuzulu valley. The inclination of the debris material accumulated zone is very low due to the fluidization and liquefaction process. The debris flows destroyed the houses that were constructed on the valley. On the other hand, the transported material by the Findıcak stream is accumulated on the valley bottom, so the small lake was formed behind the accumulated debris material. But the lake dried up due seepage of the water quickly.

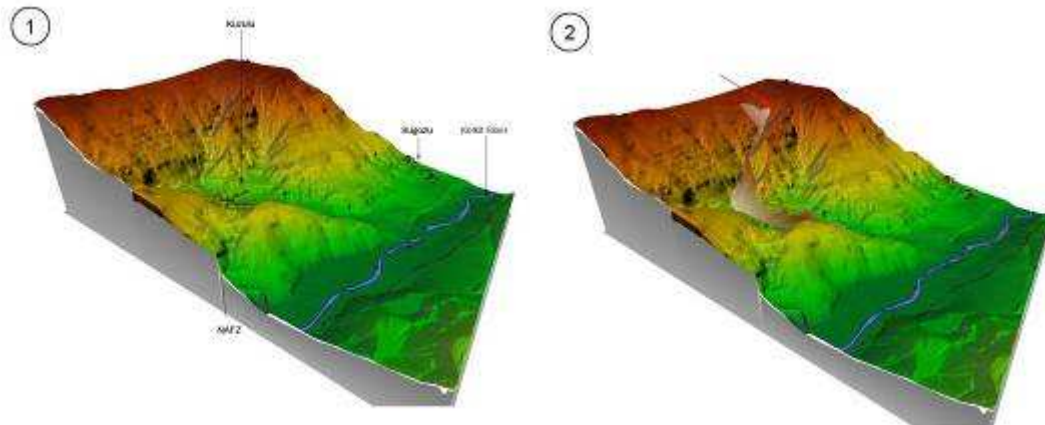
Figure-6: 3 Dimensional views stimulated by digital elevation modelling before and after the Kuzulu Landslide.

As a result the during the Kuzulu landslide the 15 millions cubic meter debris was transported from the upper part of the Kuzulu stream or the amount of the slided material is about 15 million cubic meters, and 21 houses were completely destroyed and 15 people and 375 animals died (Tatar et al., 2005;Gokceoglu et al., 2005).
