FAULT ZONE LANDSLIDES: THE EFFECTS AND GEOMORPHOLOGICAL CHARACTERISTICS OF KOYULHISAR (SİVAS-TURKEY) LANDSLIDE, MARCH 2005.

One of the landslide areas of Turkey extends along the Northern Anatolian strike-slip fault zone. The dissected topography by the running water and fault lines and well and deep weathered parent materials has led to the mass movements especially landslides. The landslide called Kuzulu occurred on 17 March 2005 caused to destroy of the most part of the Kuzulu village and 15 people and 375 animals died. During the landslide a 15 million cubic meter materials has been slid from the original part and accumulated on the valley bottom.

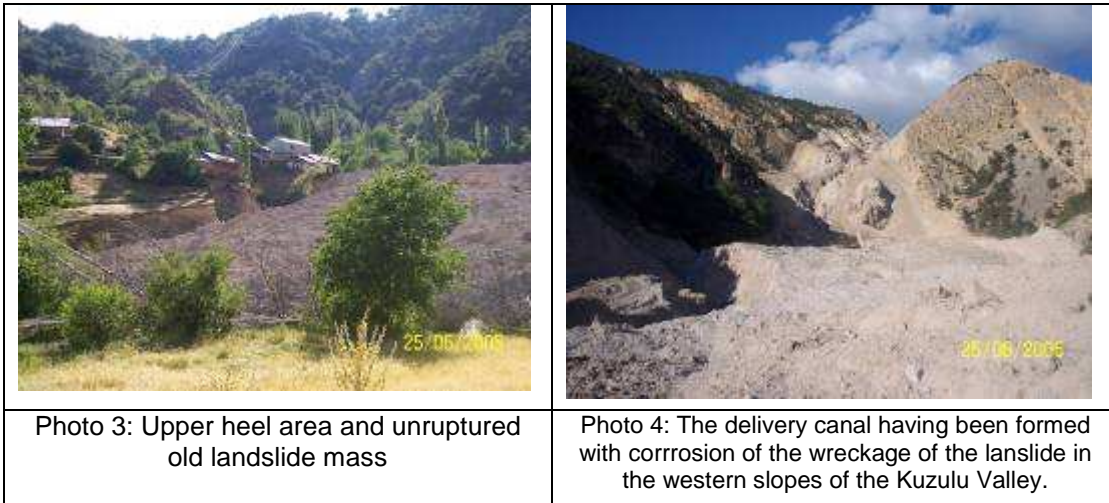
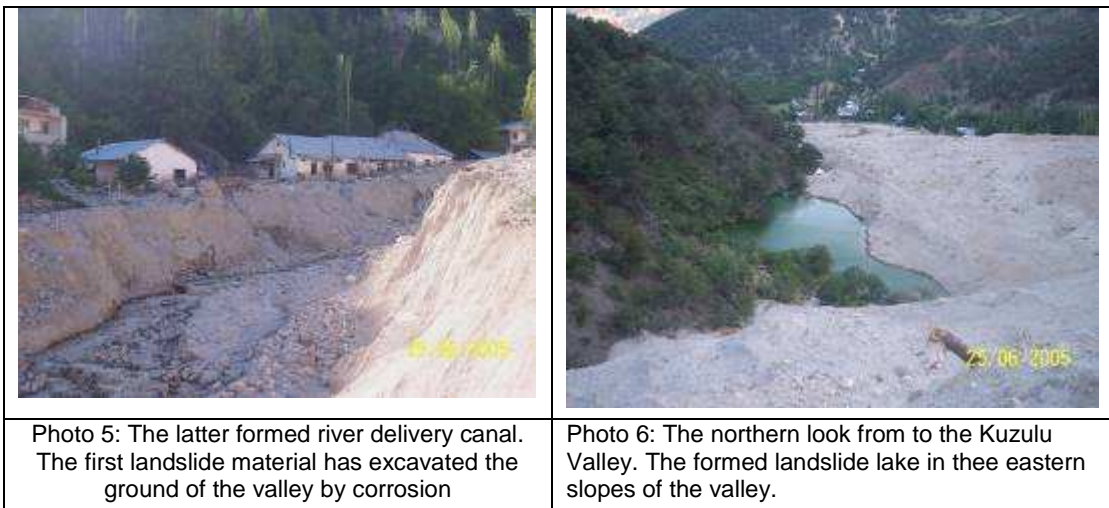
The andesite and andesitic tuffs overlying the mesozoic volcano-sedimentary formation deeply weathered. These weathered materials have slid towards the south direction along the valley. On the other hand it can be clearly seen paleolandslide and its

debris in that area. This debris provided an additional material in the formation of recent landslide.
